**Gypsum in Minoan Architecture: Exploitation,
Utilisation and Weathering of a Prestige Stone**

Vol.I: Text

STEPHANIA CHLOUVERAKI

Institute of Archaeology

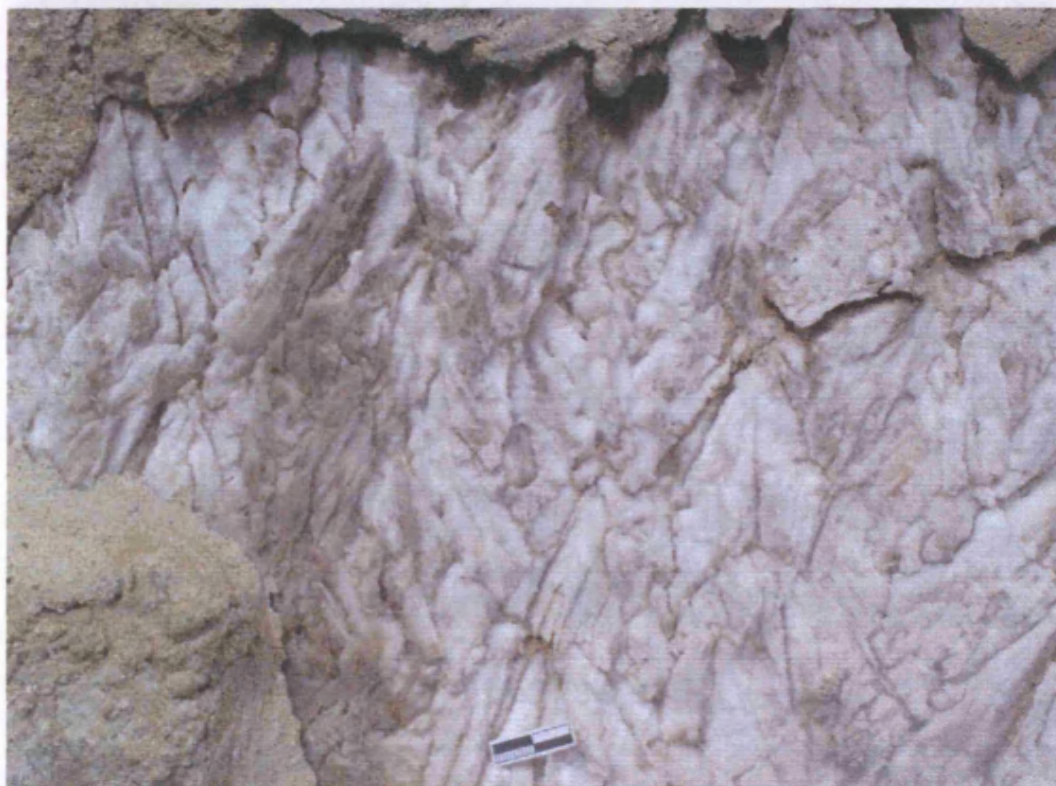
Fig 4.63: selenite pseudomorphs of the upper block of the north jamb in Magazine VII

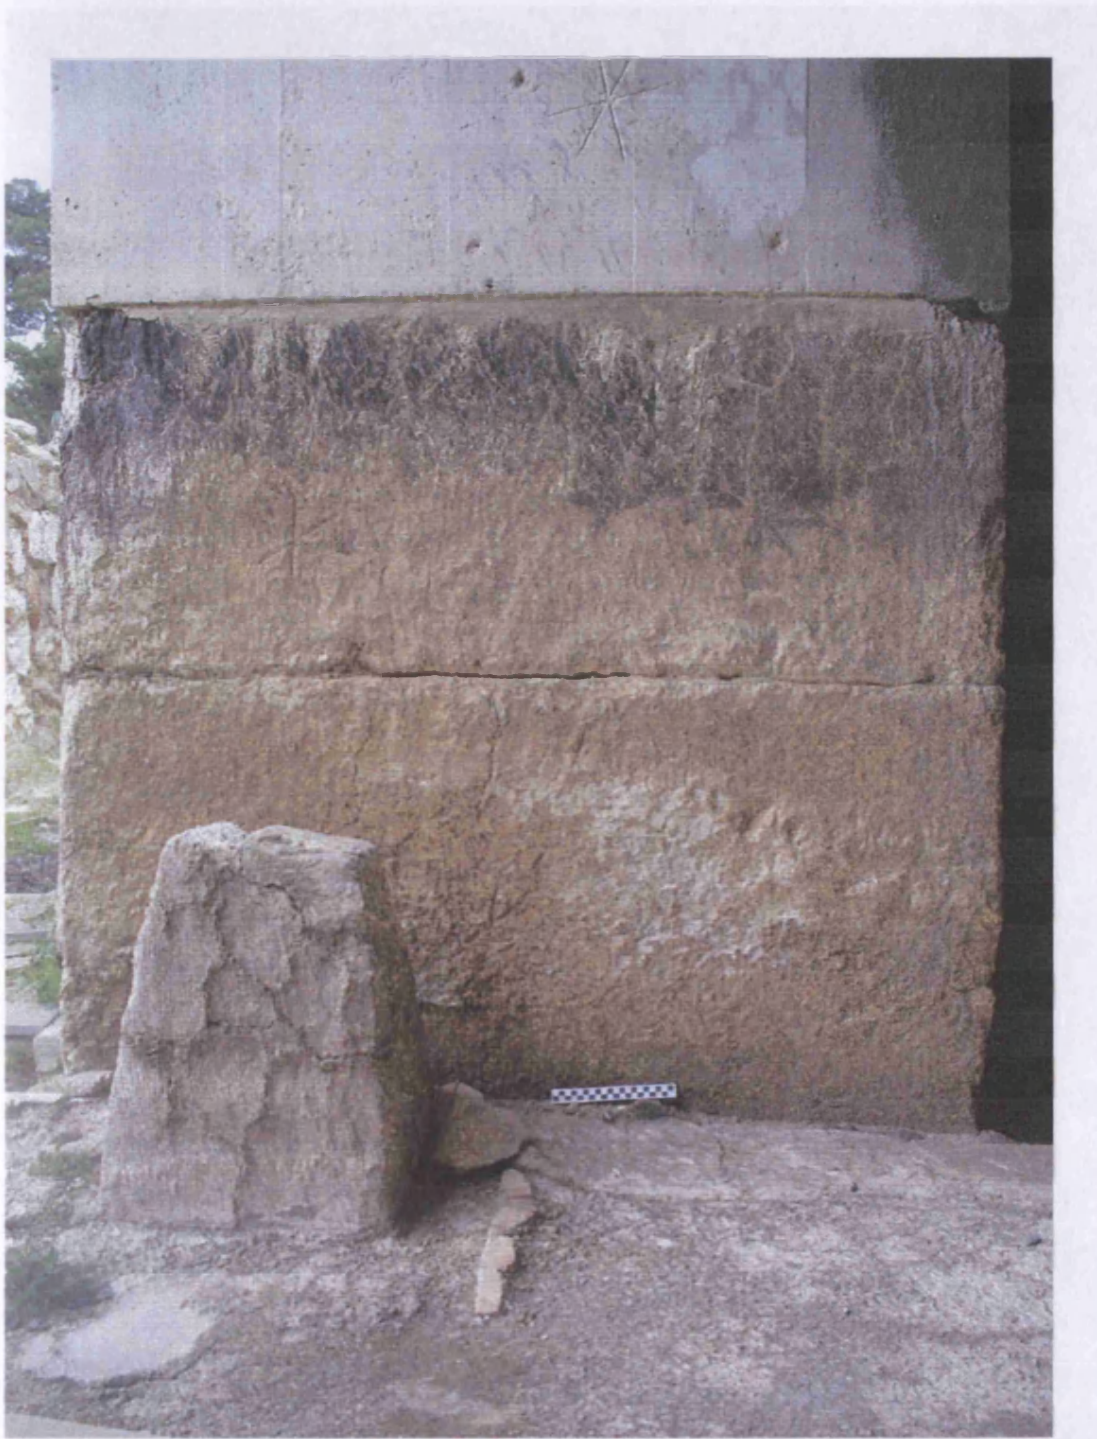
Fig. 5.64: the south jamb of Magazine VIII

This is the first of five magazines (VIII-XII) that were roofed over by Evans and therefore all the architectural gypsum is preserved in a much better condition, similar to that of the first three magazines which are also roofed. The blocks of the south jamb (KN1689-1690) are both marked, the upper with two stars and the lower with one. They are the widest jambs (1,54m) along with those between Magazine X and XII (1,58m) (Fig.5.64). The light in the roofed magazines is very poor as the only sources are the small sky windows plus the entrance and thus is difficult to make detailed observations on gypsum surfaces. In addition, parts of the south and the north walls are hidden by pithoi that are standing against them (Fig.5.65). It is obvious, however, that the preservation of the material is far better than it is in the outdoor magazines and that there are various tool marks preserved on the surface of the blocks. There are orthostates against the wall that have double mason's marks incised on their surface according to Evans note on the plan mentioned above. The fire marks in front of this magazine are quite interesting. The floor slab in front of the south jamb is only partly affected by fire while the front surface of the jamb behind it and the traces of a wall dado that was set against it are entirely burnt showing clearly that the floor slab is of later date (Fig.5.65).

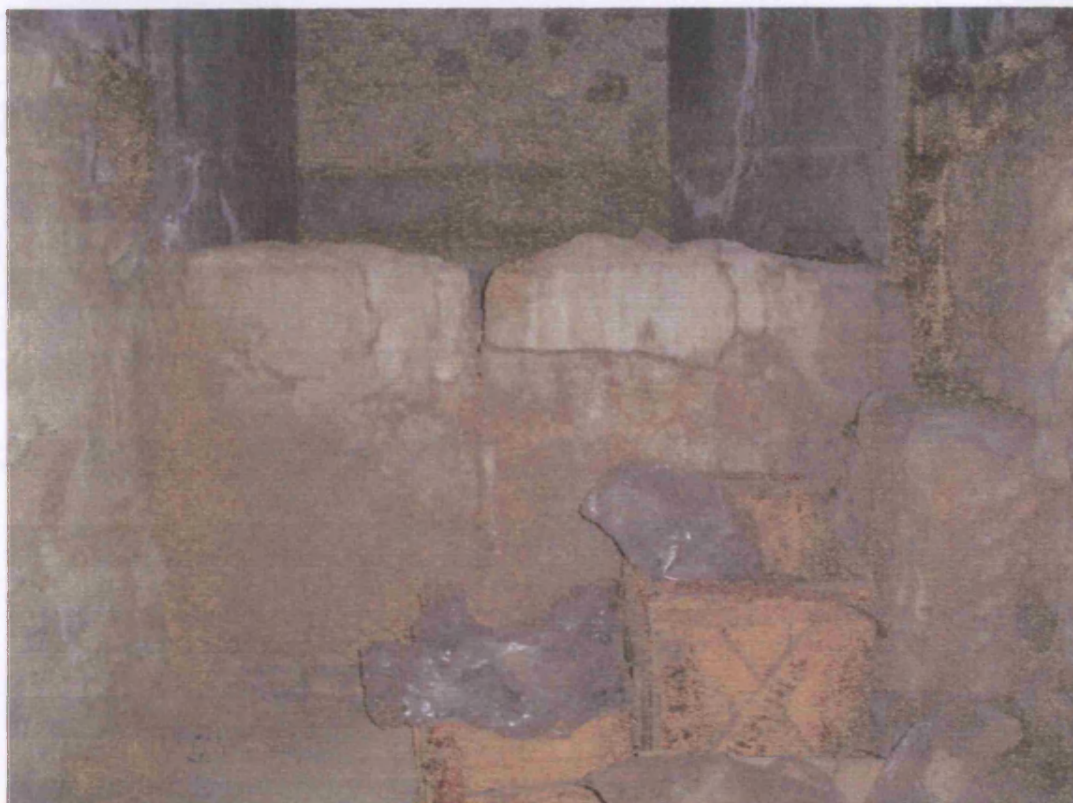
Fig. 5.69: the orthostates of the west wall in Magazine X

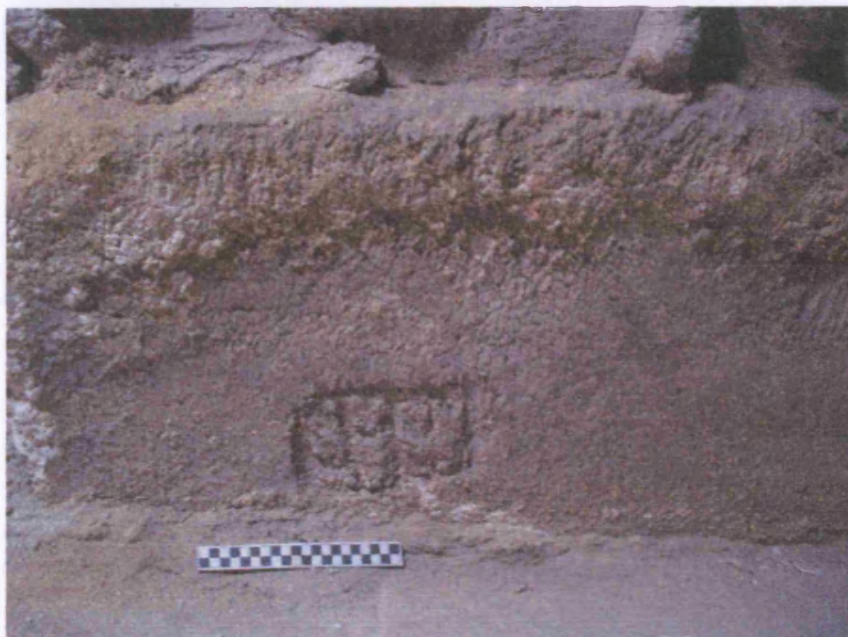
Fig. 5.75: mason's mark in Magazine XII

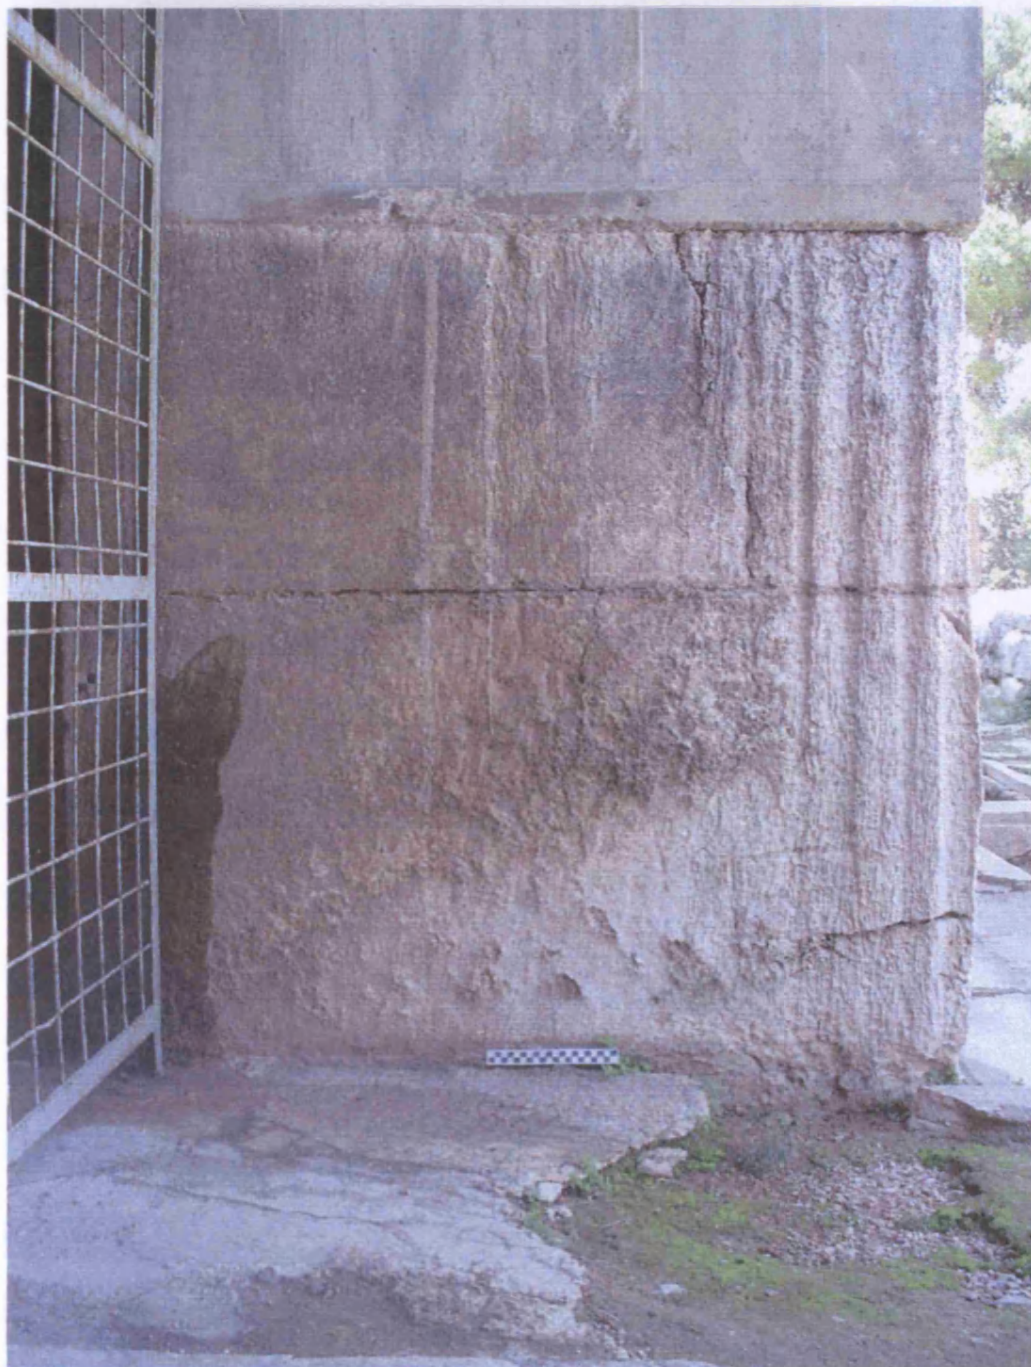
Fig. 5.77: the south jamb of Magazine XIII

From Magazine XIII and onwards the building remains are exposed to an outdoor environment and the preservation of gypsum is quite poor. Details such as tool marks and masons marks are rarely preserved. The blocks of the south jamb (*KN1679-1680*) that are partly covered by the restoration structure above are in a much better condition than those of the north jamb that are exposed to the rain. The upper block has a 'branch' mark incised on its surface that is barely visible, while the lower one has two 'gate' marks. On this jamb one can observe the difference in the state of preservation between sheltered and unsheltered gypsum. The side that is exposed to rain water shows deep dissolution flutes while the sheltered side of the same block is stained but preserves its original surface (Fig.5.77). The north jamb is entirely exposed to outdoors environment and its selenite blocks show severe weathering, mostly due to rain and biological colonisation. Each of them is incised with a 'branch' mark but the upper one can be barely seen (Fig.5.78). The effects of rain water are apparent on the gypsum slabs of the floor and the cists. The floor is paved with selenite slabs that are completely burnt and the majority of them are also stained black (Fig.5.79). The same applies to the lining of the cists (Fig.5.80). Hallager (1977) dates the floor of this magazine to the beginning of the LMIIIA renovation/restoration works in the palace, probably contemporary with the earlier floor that is visible in Magazine XII. Along the south and north walls there are remains of wall dadoes that run along the entire length of the corridor. A 'gate' mason's mark is also visible on the surface of a reused block of the south wall that is almost unaffected by fire (Fig.5.81). It was either the dadoes or wall plaster that dressed the wall at an earlier time that protected the lower part of the wall from fire. A second 'gate' mark and a 'double axe' are preserved on two blocks of the north wall.

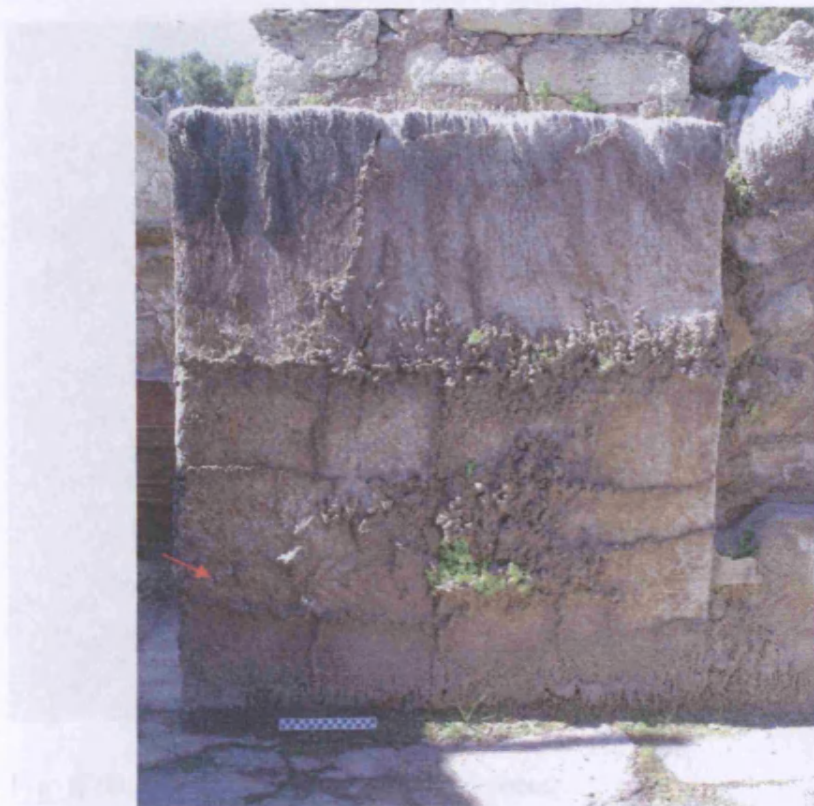
Fig. 5.78: the north jamb of Magazine XIII

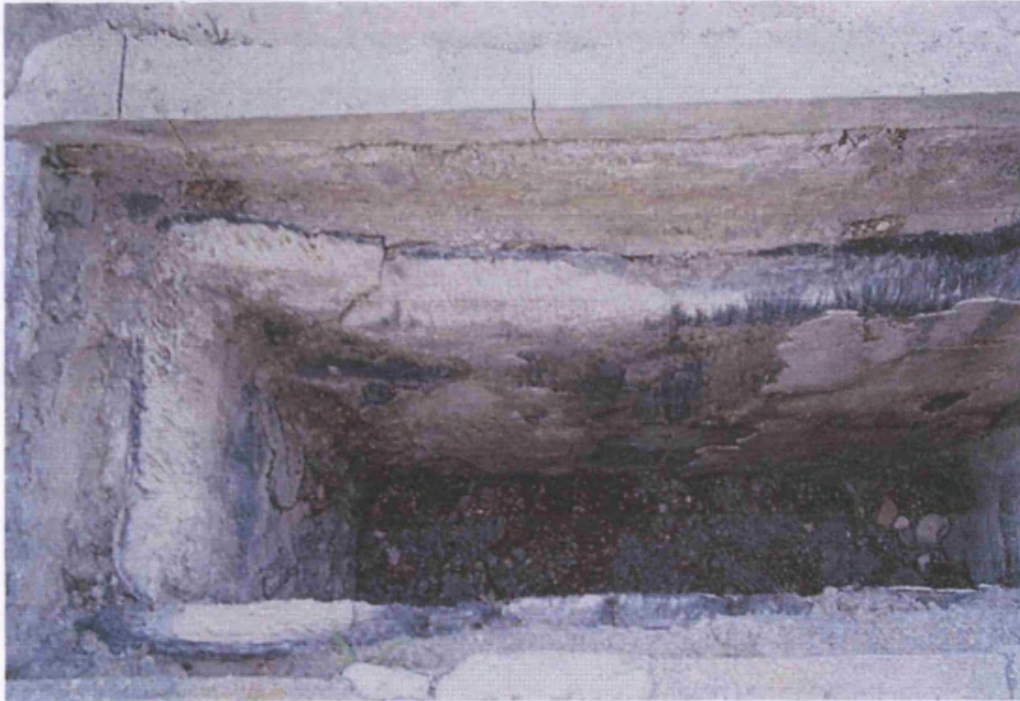
Fig. 5.80: cist lining sealed with lead sheet

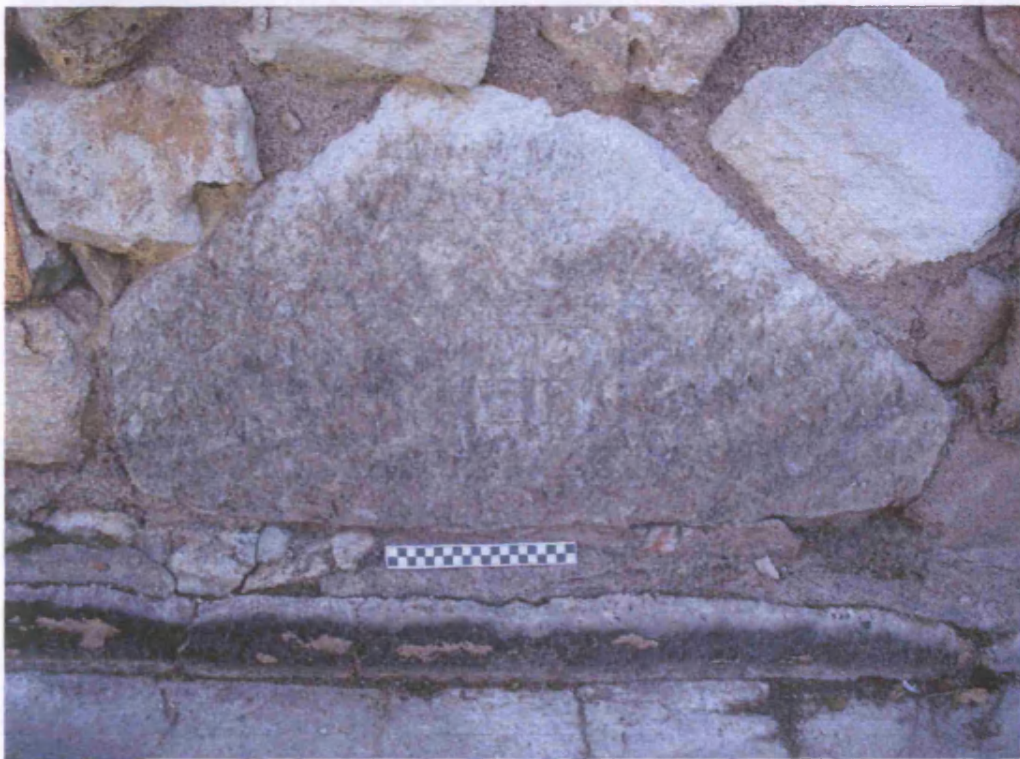
Fig. 5.81: wall dadoes against the south wall of Magazine XIII and in front of a reused block with a gate mason's mark

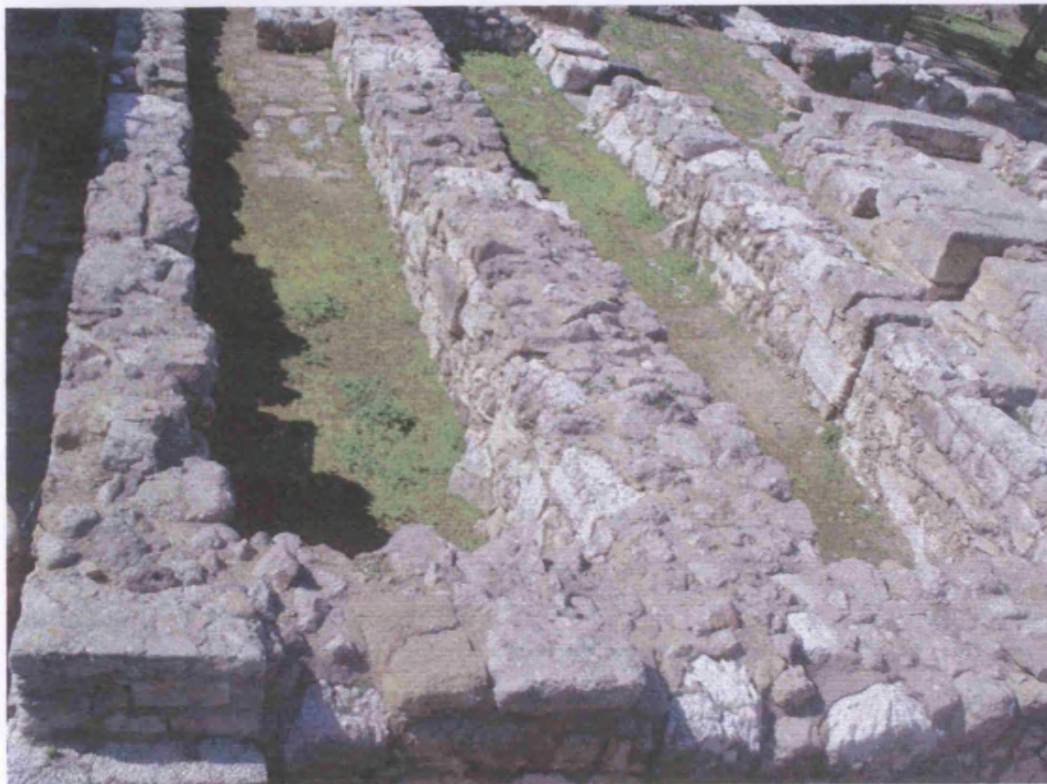
Fig. 5.82: general view of Magazines XIV-XVI

The last four magazines are all exposed to rain and the preservation of gypsum is very poor (Fig.5.82 and Appendix 1: Plan 5). However the same general observations can be made on the walls as regards the construction technique. Several selenite blocks and very few 'nodular and lenticular' are built in the walls in secondary use. The east entrance of Magazines XIV-XVI has been blocked and there are no gypsum jambs on this side. A course of wall dadoes was installed against this wall once their east entrance was blocked (Fig.5.83). These magazines have access from the west. There is a large selenite block at the west end of the south wall of Magazine XV (Fig.5.84) and another two, one on top of the other, at the west end of north wall of the same magazine (Fig.5.85). There is no gypsum floor pavement in these magazines apart from some traces found in Magazine XV. Magazine XVII, however, also has an entrance in the east with the usual large gypsum jambs. Both selenite blocks of the south jamb and the lower one of the north (Fig.5.86) are preserved but heavily weathered. The floor is also paved with gypsum slabs, mainly selenite that is heavily burnt and large missing parts of it are reconstructed in concrete. There are four floor cists but their gypsum lining is missing (Fig.5.87).

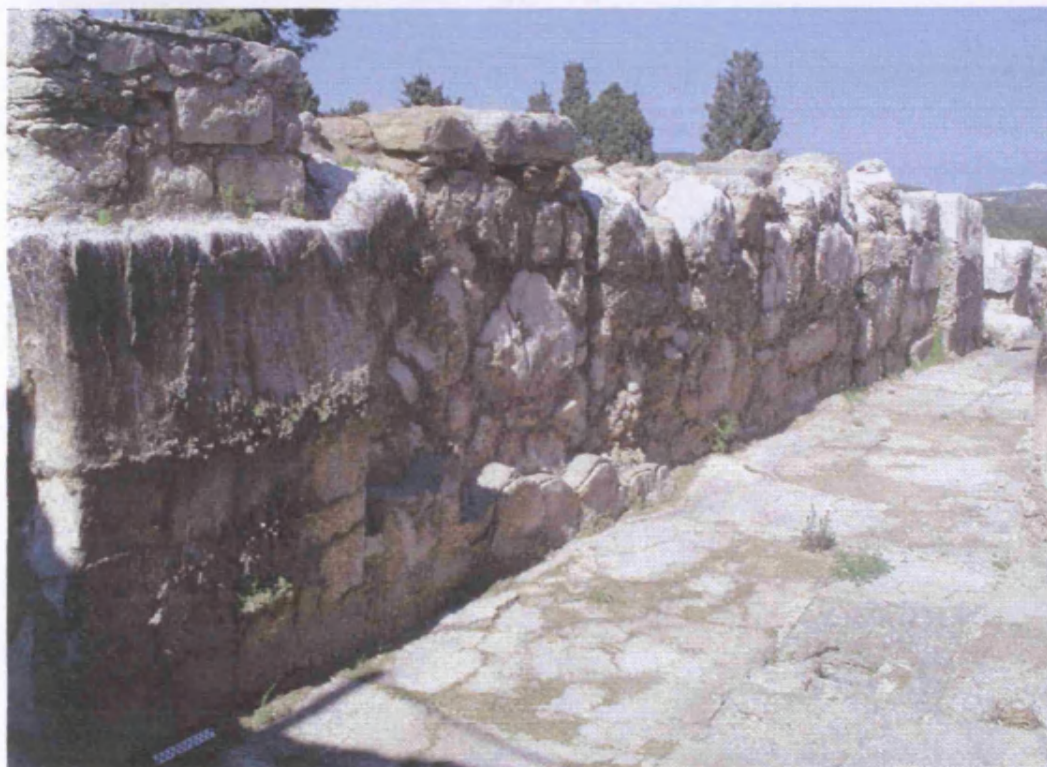
Fig. 5.83: wall dado remains along the south wall of the Long Gallery north of Magazine XIII

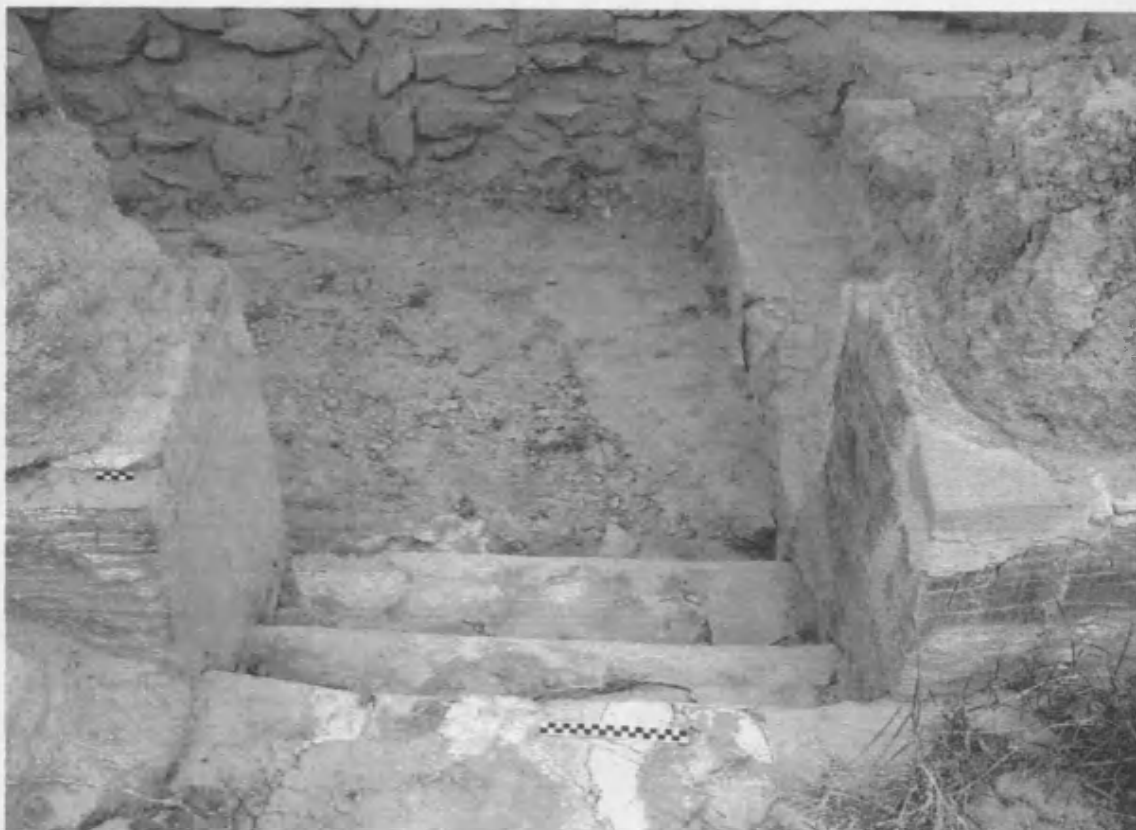
Fig. 5.315: the staircase from Room 2 to 75, with gypsum piers on either side

Room 2 is a small elongated room that communicates with the halls through a door at its north-west corner and gives access to the landing of staircase 75 through a three step staircase (1m wide) at its south-east corner (AT461-463, Appendix 1: Drawing 53). Two large gypsum piers are placed laterally at the staircase (AT460 and 464, 0.82x0.70x0.71m) (Fig.3.415). The south wall is veneered with gypsum dadoes and a bench that runs along its entire length (Fig.5.316). A second gypsum bench runs along the east wall, while on the north wall is preserved a wall dado next to the door (Fig.5.317). The benches are the same as those in Portico 1 but of different lengths. According to the plan in the final publication the floor seems to be paved with four

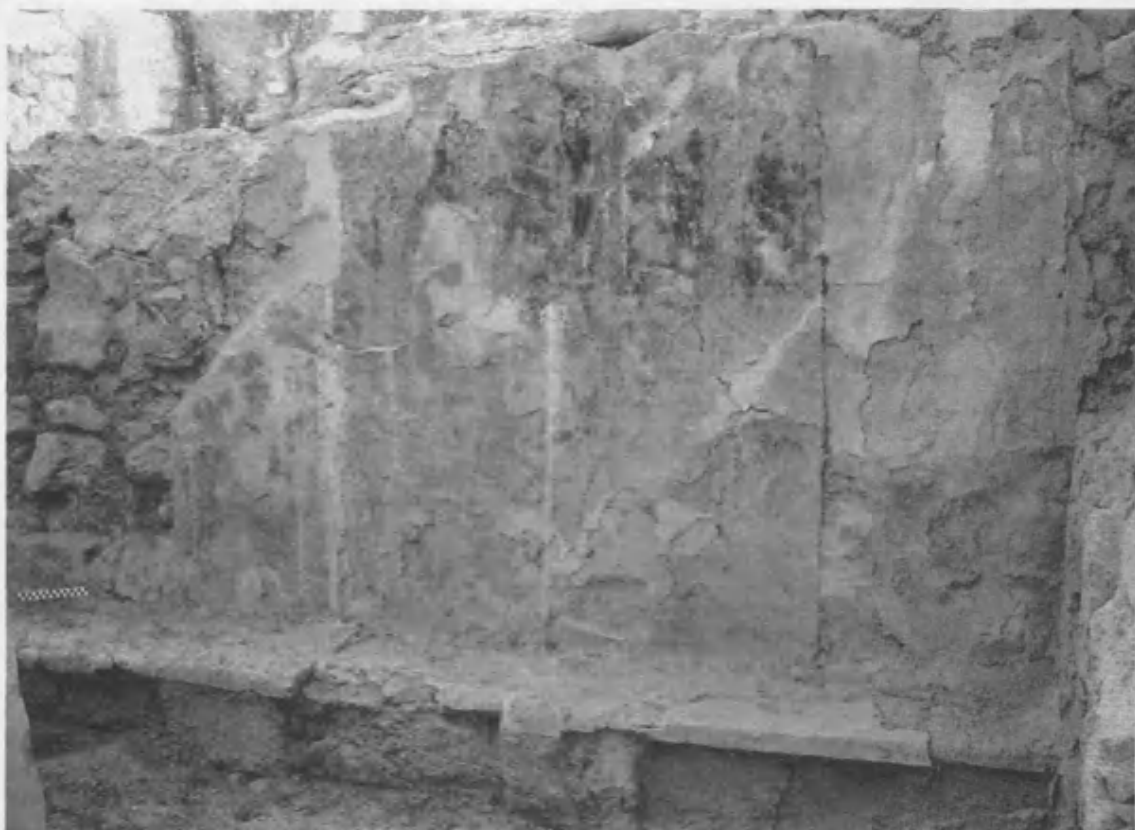
Fig. 5.316: the south bench and wall dadoes in Room 2

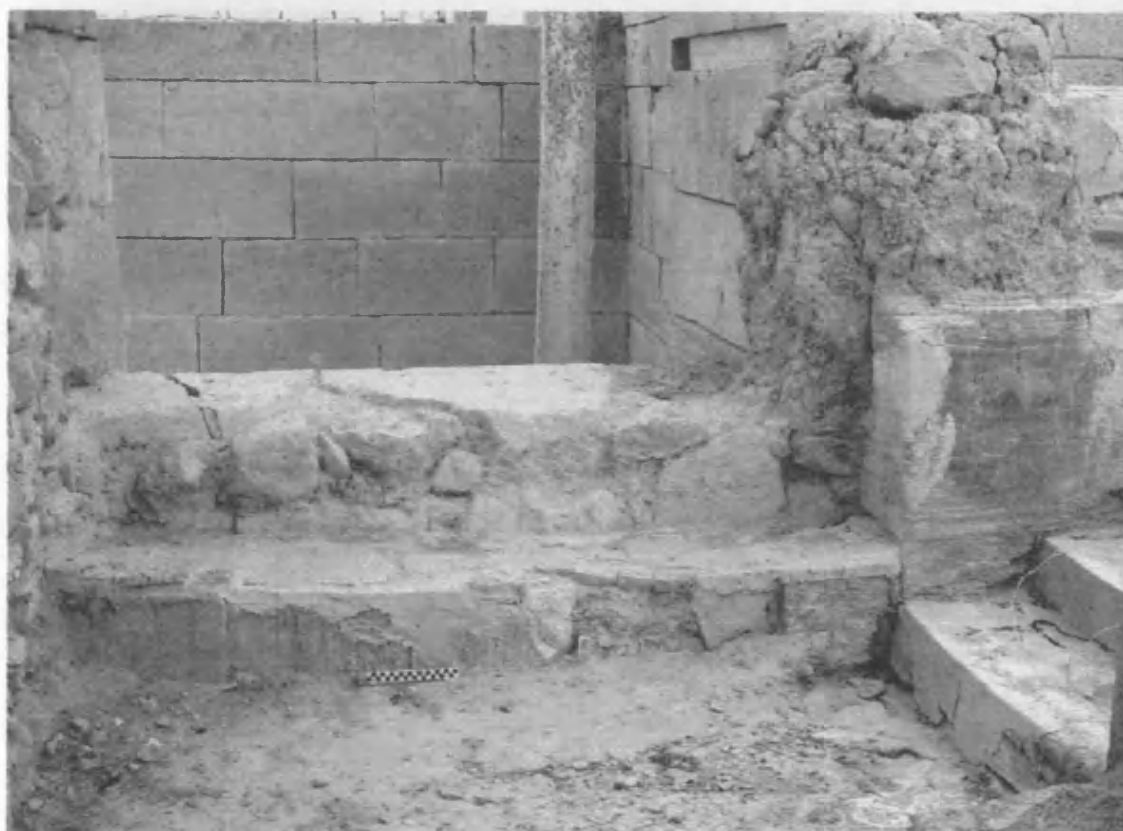
Fig. 5.317: the east bench in Room 2

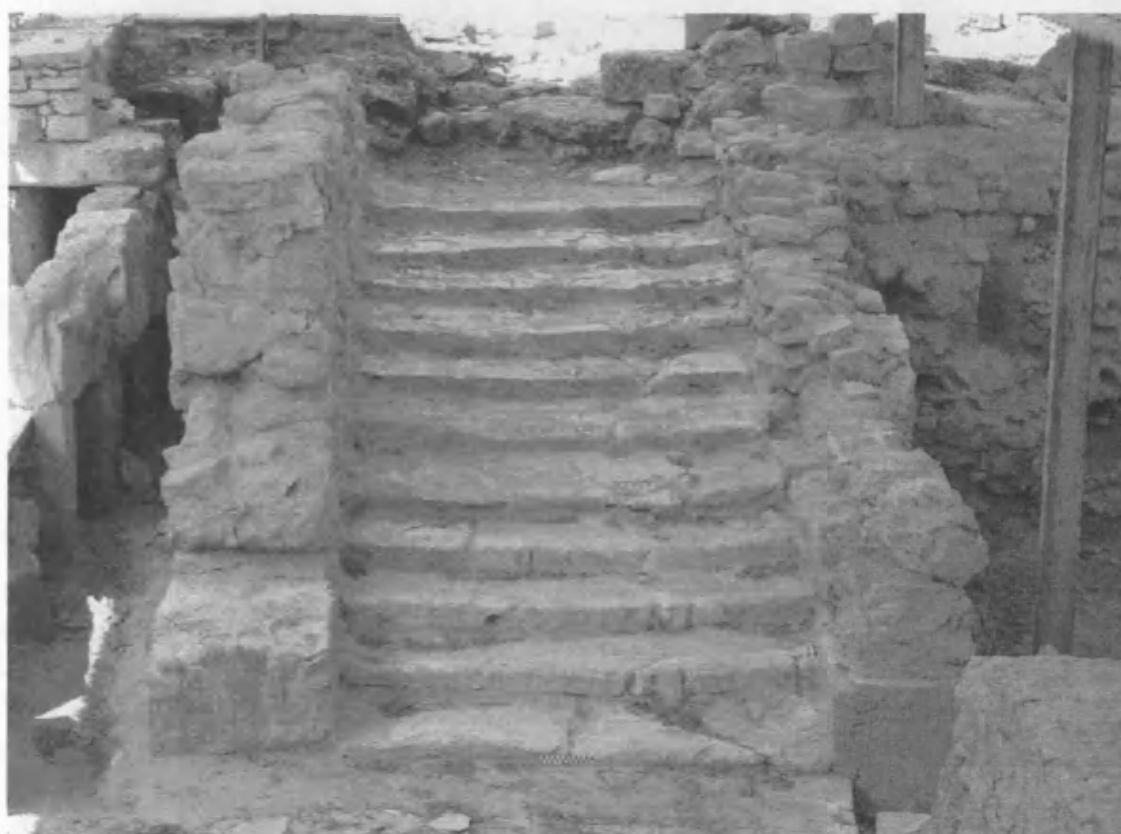
Fig. 5.318: Staircase 75 from east

The staircase is the largest in the whole villa (1.88 wide) and consists of ten gypsum treads (*AT491-500*) (Fig.5.318). It has a common pier (*AT460*) with the small (1m wide) three step staircase, which lands in Room 2 and which can be considered as the first flight of the same staircase, and a second pier (*AT490*) of the same size on the other side (south parapet). The landing in between the two flights forms a small room with a gypsum pavement and benches along the east and the south walls (Fig.5.319, Appendix 1: Drawing 54). As in the previous rooms the floor slabs are not visible but are described by the excavators and are shown in the general plan of the site, forming parallel rectangular panels (Plan 4.4) (Halbherr *et al.* 1951:152).

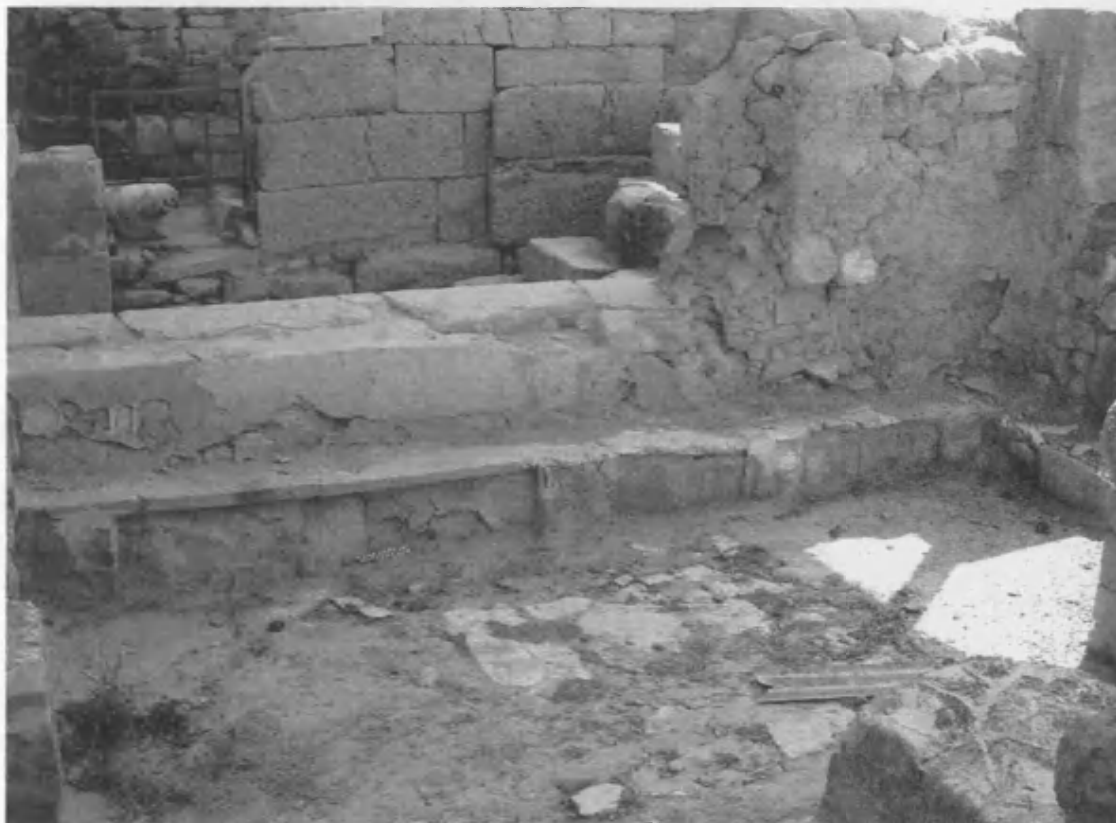
Fig. 5.319: the east and part of the south (on the right) bench in Room 75
